# FULL RESERVE STUDY

## Cross Keys Condominium I

**Baltimore, Maryland**  
**September 29, 2020**

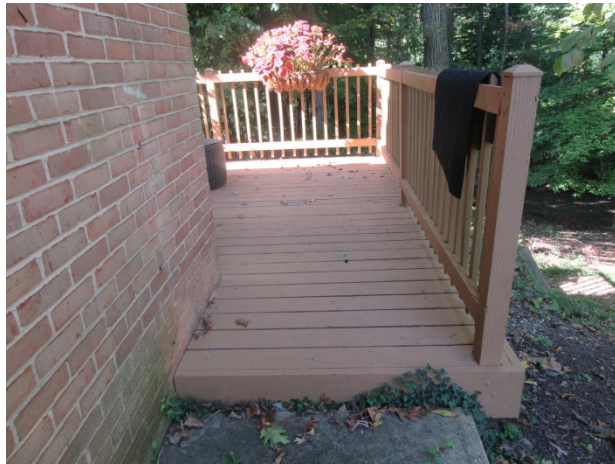
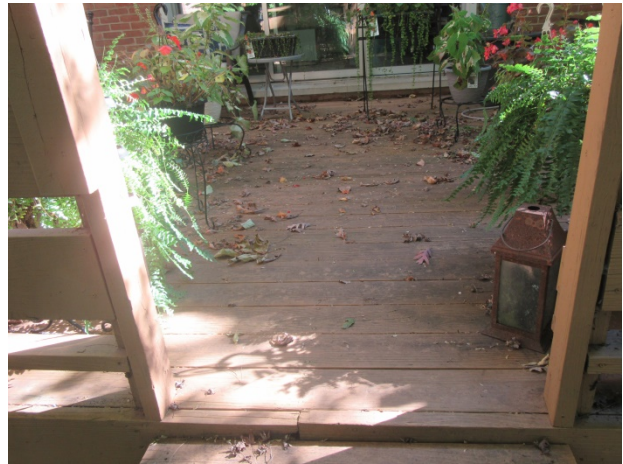
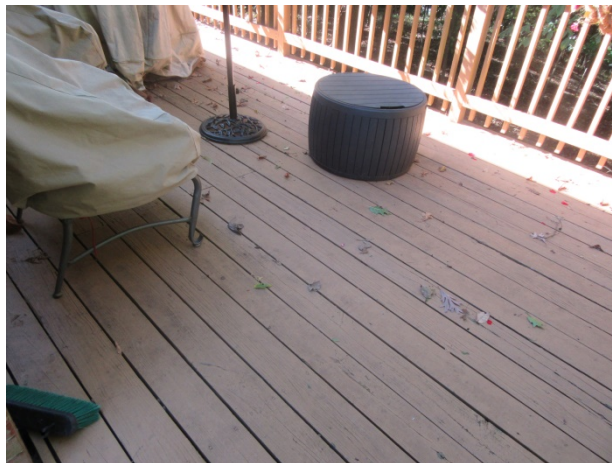
**Condition:** Reported in fair overall condition

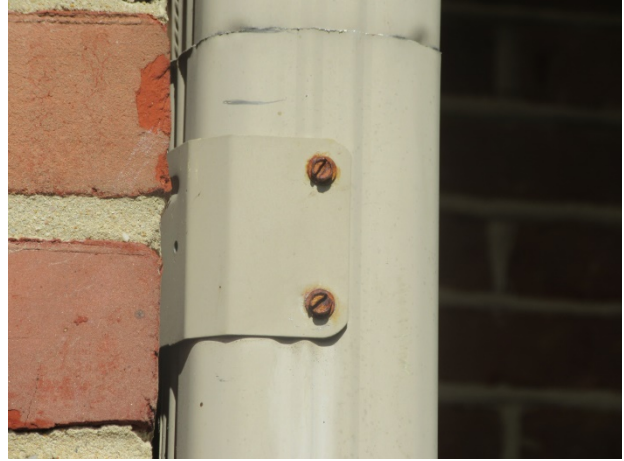
**Condition:** Varying from good to fair; the gutters and downspouts replaced from 2017 through 2019 are in good overall condition with isolated fasteners rust. The remaining gutters and downspouts are in fair overall condition with weathered finish evident.

**Downspout fastener rust**

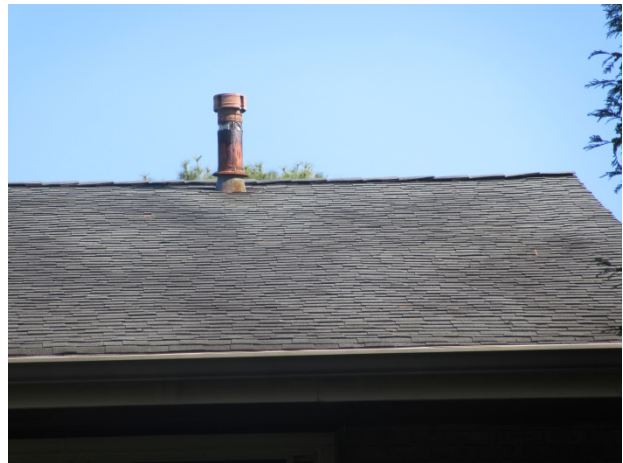
**Condition:** Varying from good to fair. Roofs replaced from 2017 through 2019 are in good overall condition. The remaining roofs are in fair overall condition with stains, previous repairs, and shingle lift evident from our visual inspection from the ground.

**Asphalt shingle roof stains**

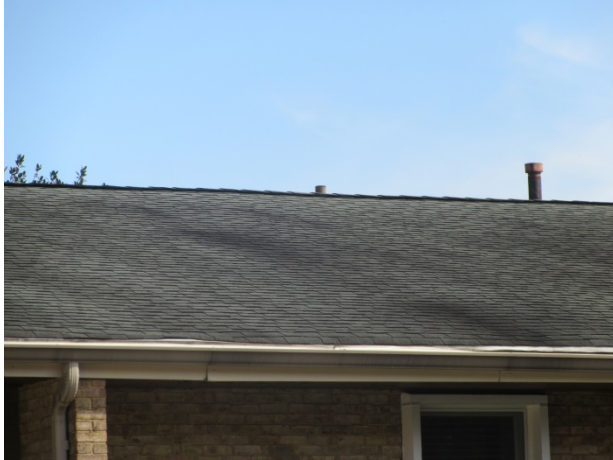
**Asphalt shingle roofs stains**

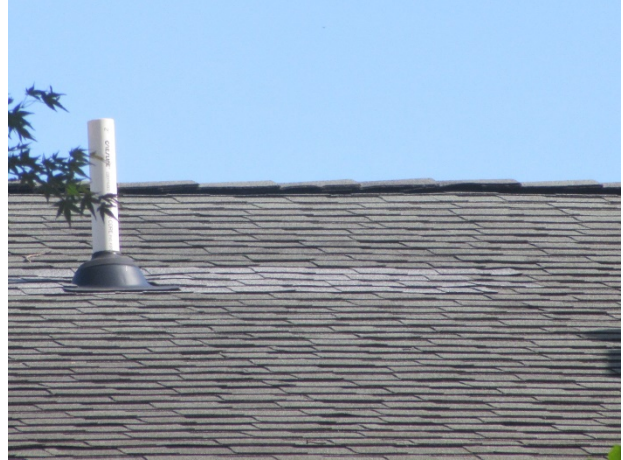
**Asphalt shingle roof previous repairs**

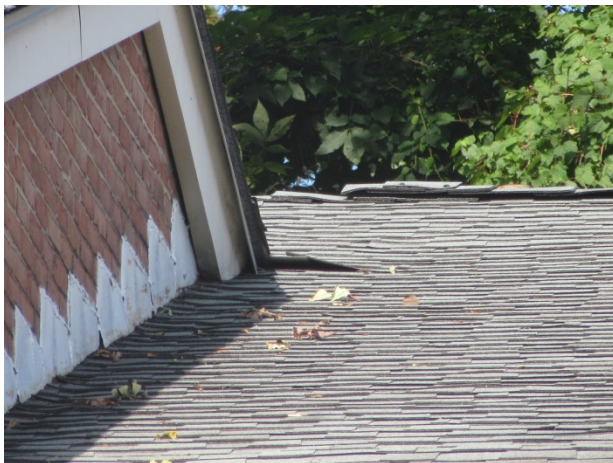
**Asphalt shingle lift**

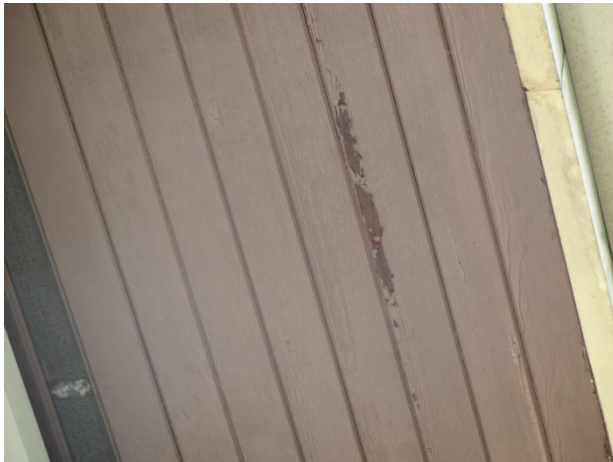
**Condition:** Fair to poor overall with deterioration evident

**Soffit minor deterioration**

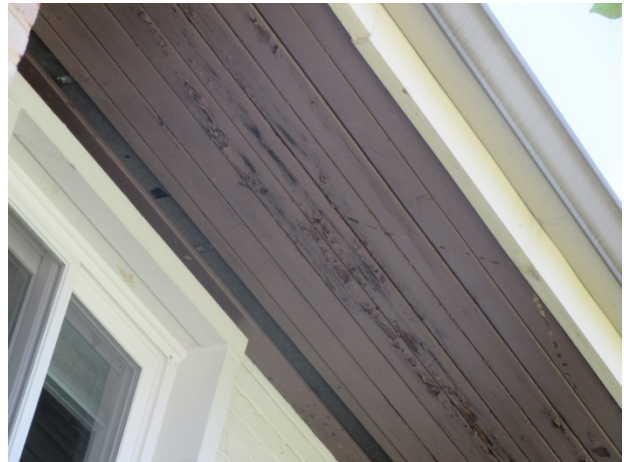
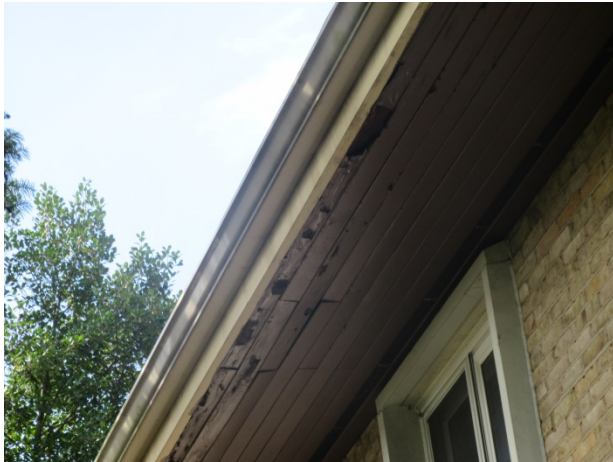
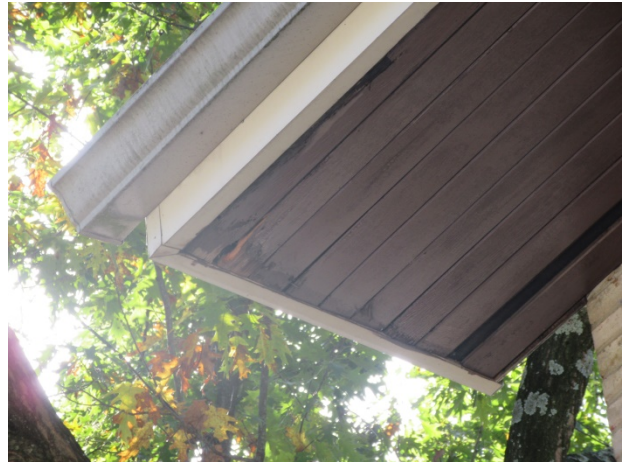
**Soffit deterioration**

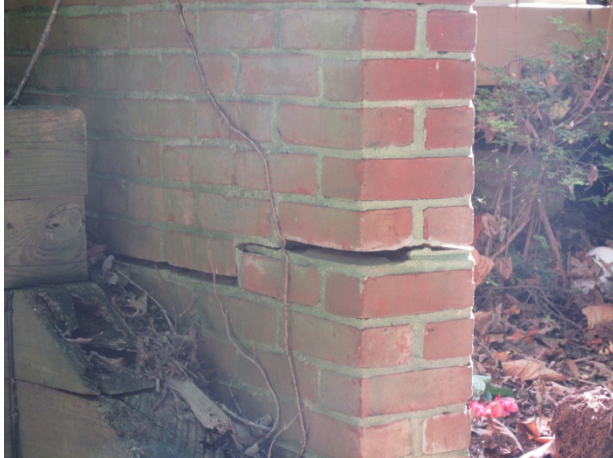
**Condition:** Fair overall with the following evident:

**Mortar cracks and deterioration**

**Useful Life:** We advise a complete inspection of the masonry and related masonry repairs every 8- to 12-years to forestall deterioration.

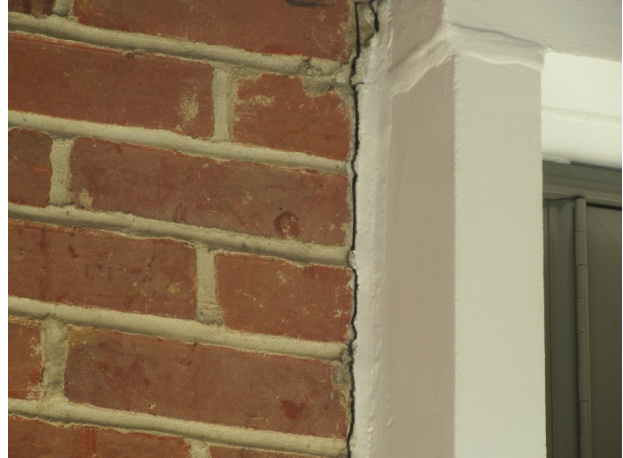
**Sealant cracks**

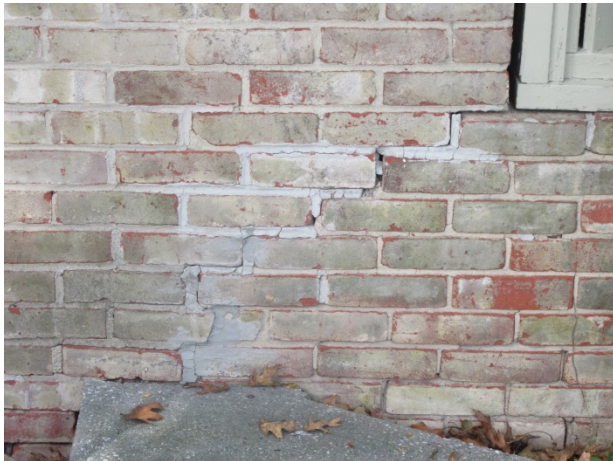
**Previous repairs and mortar deterioration**

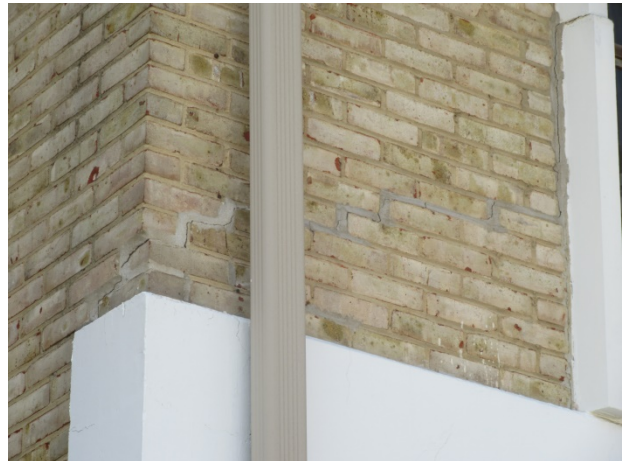
**Previous repairs**

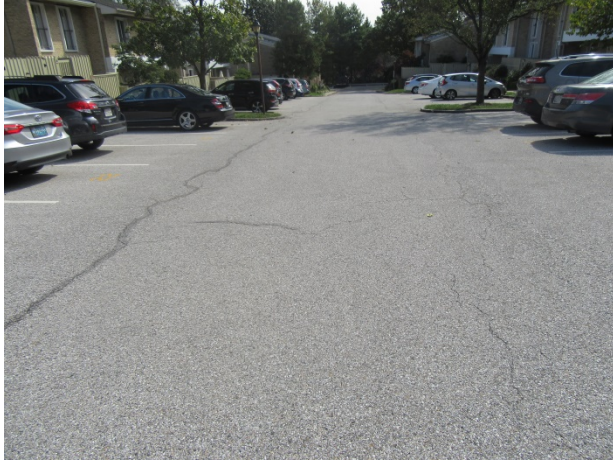
**Condition:** Good to fair overall with previous repairs, cracks, and isolated minor deterioration evident

**Asphalt pavement; we note minor cracks and previous repairs**

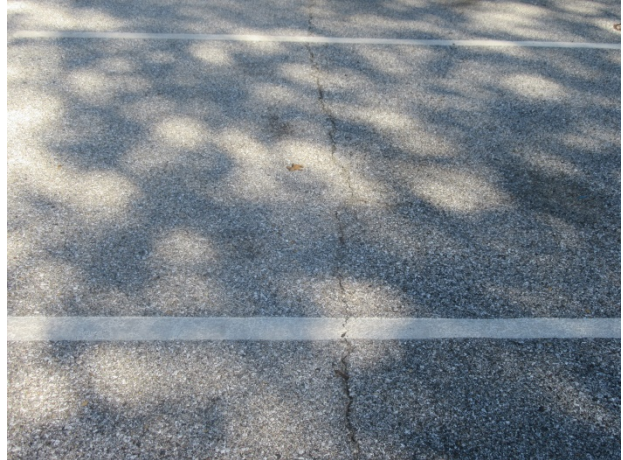
**Asphalt pavement cracks**

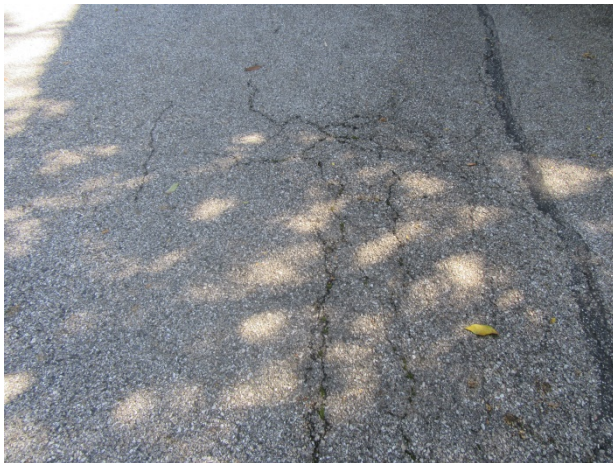
**Asphalt pavement cracks, previous repairs, and minor deterioration**

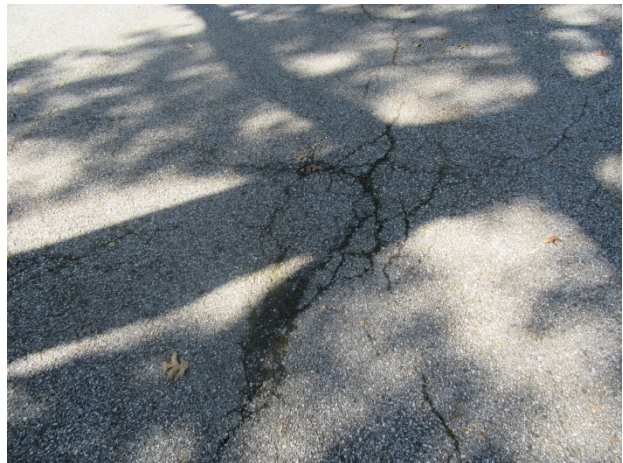
**Asphalt pavement cracks and minor deterioration**

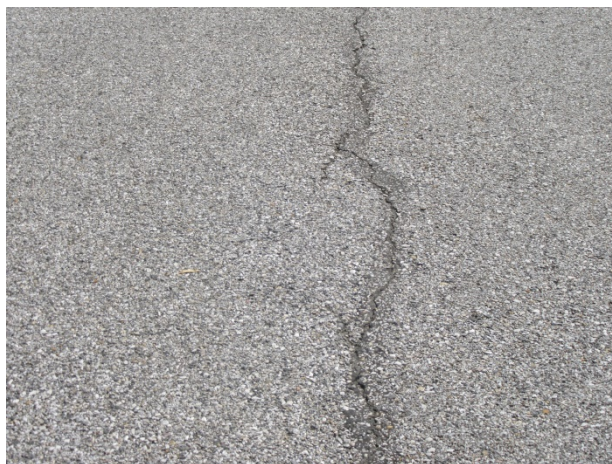
**Asphalt pavement crack**

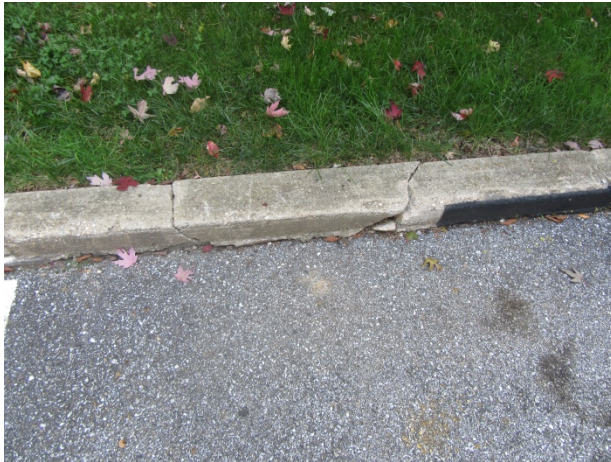
**Condition:** Fair overall with cracks and deterioration evident

**Concrete curb cracks and deterioration**

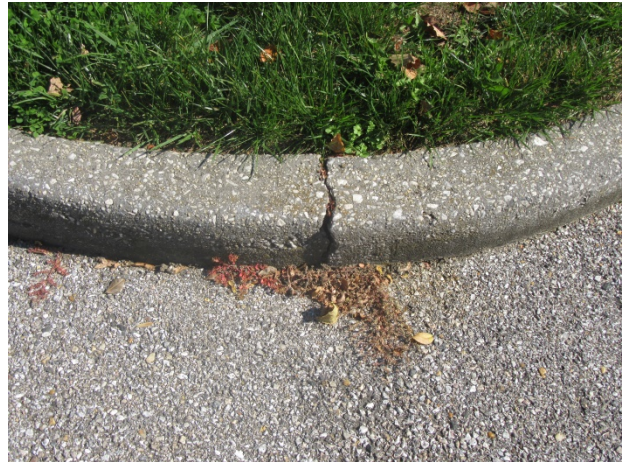
**Concrete curb crack**

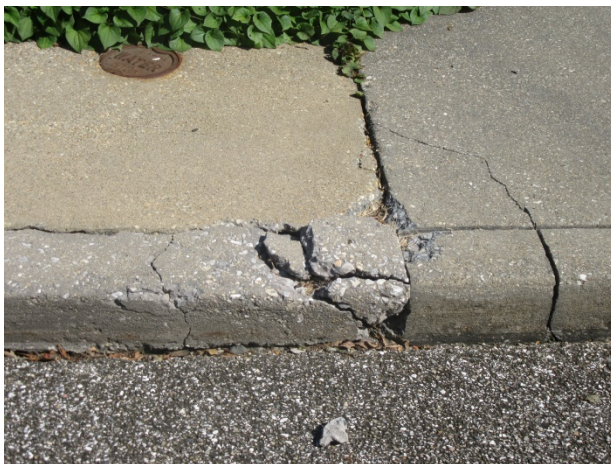
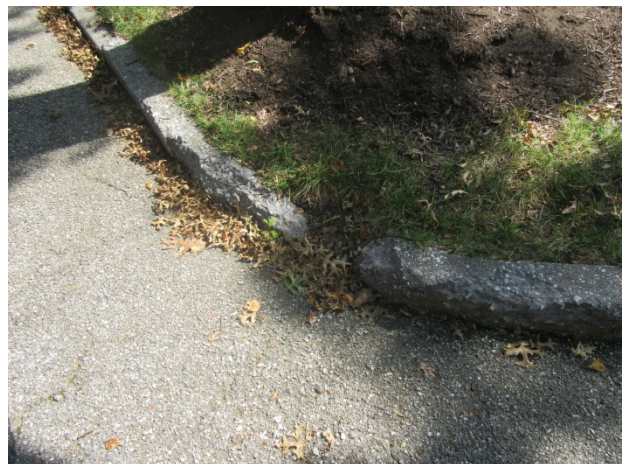
**Concrete curb deterioration**

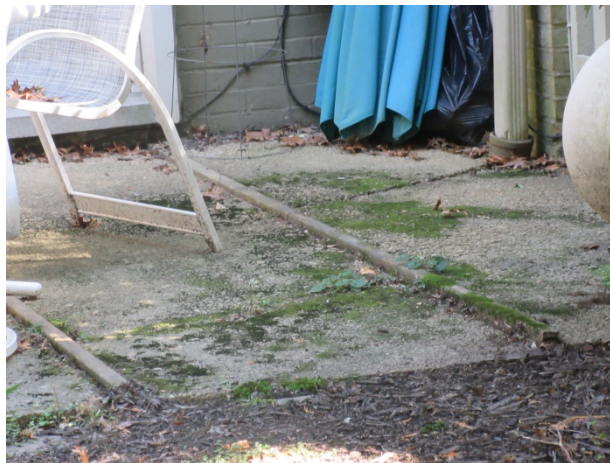
**Condition:** We were unable to inspect all patios due to privacy fences. The patios we inspected are in fair overall condition with organic growth and deterioration evident

**Concrete patio; we note organic growth and deterioration**

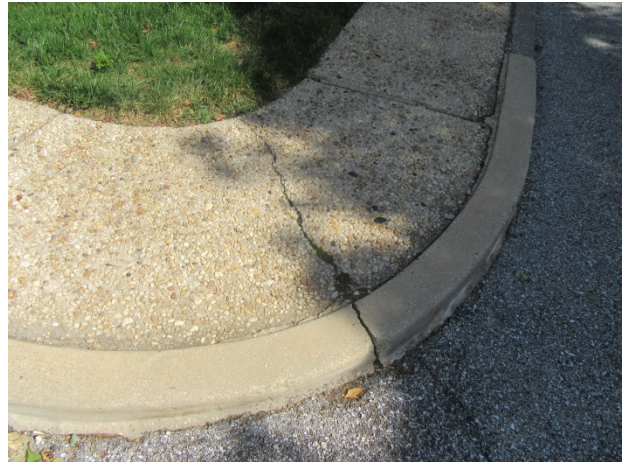
**Condition:** Fair overall with cracks, spalling, and deterioration evident

Concrete sidewalk crack

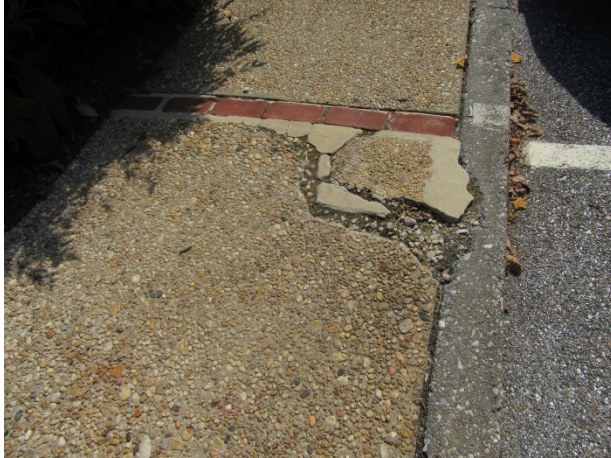
**Concrete sidewalk deterioration**

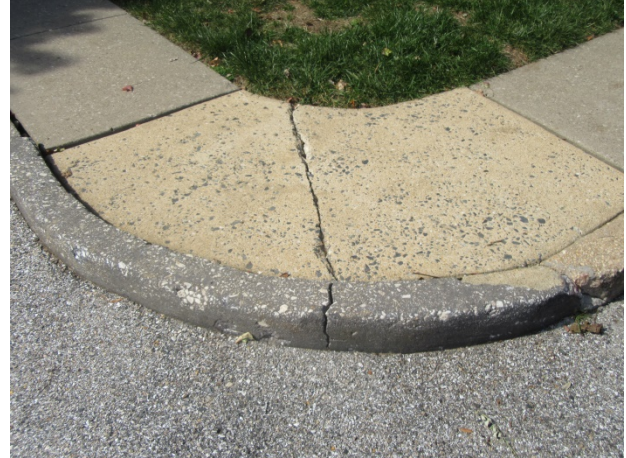
**Concrete sidewalk crack and spall**

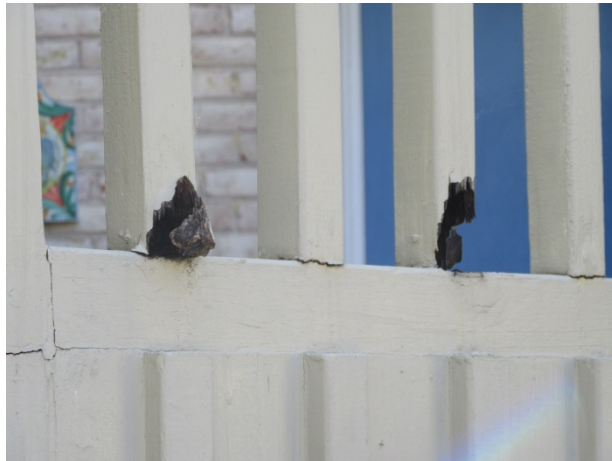
**Condition:** Good to fair overall with isolated deterioration evident

**Wood fence deterioration at unit 54**

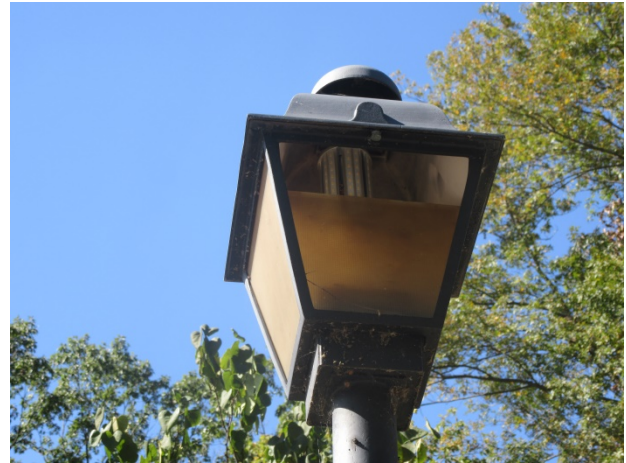
**Condition:** Fair overall with damage fixture evident

Damaged light fixture at Bouton Court. We assume the Association will replace this light fixture in the near term and fund this activity through the operating budget

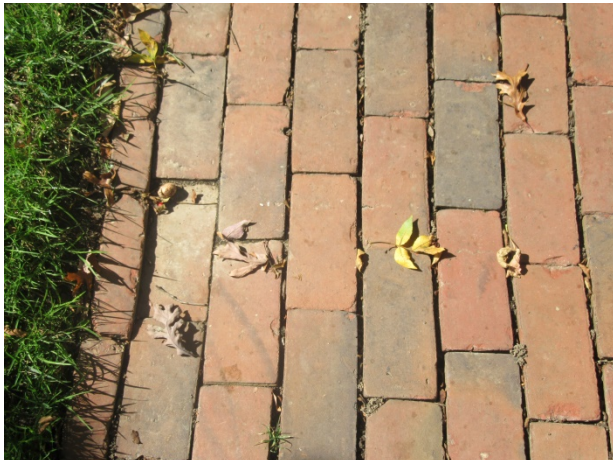
**Condition:** Good to fair overall with displaced pavers, organic and vegetation growth evident

**Pavers displacement and vegetation growth**

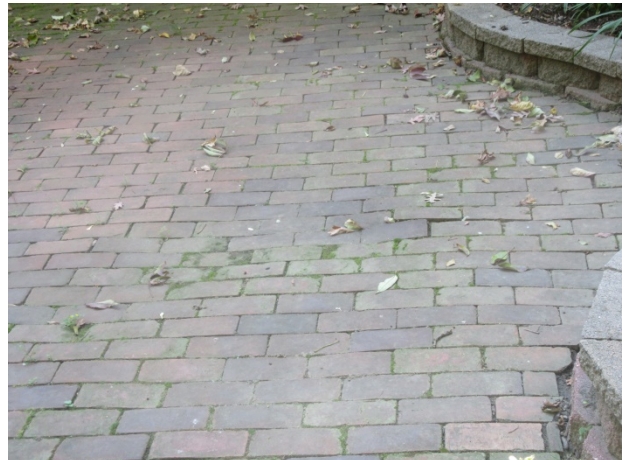
**Pavers displacement and organic growth**

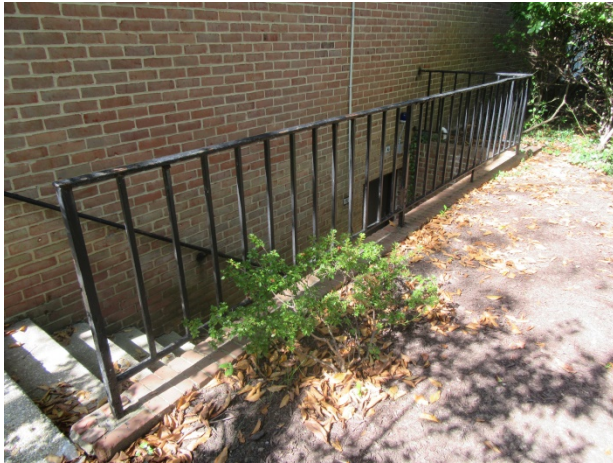
**Condition:** Fair to poor overall with rust and deterioration evident.

**Metal railings; we note rust and finish deterioration**

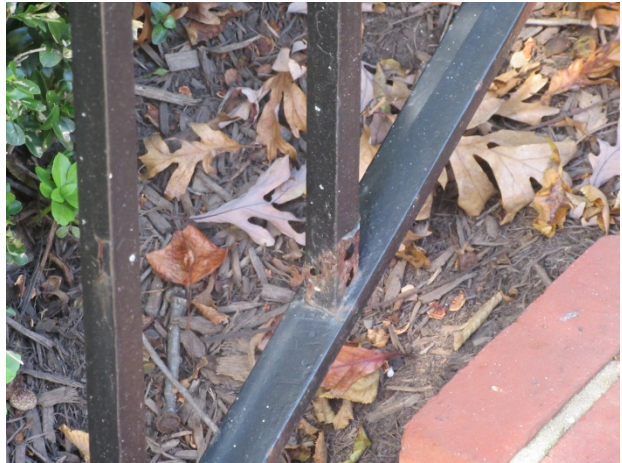
**Metal railings rust and deterioration**

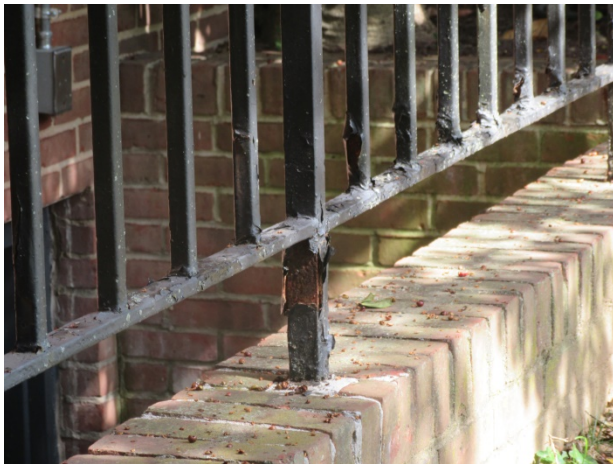
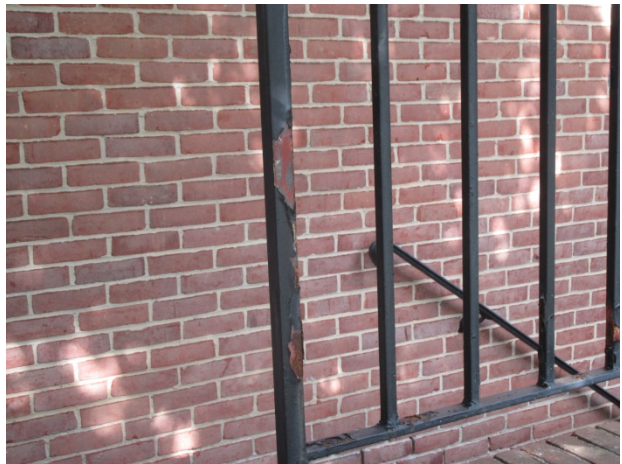
**Metal railings rust and finish deterioration**

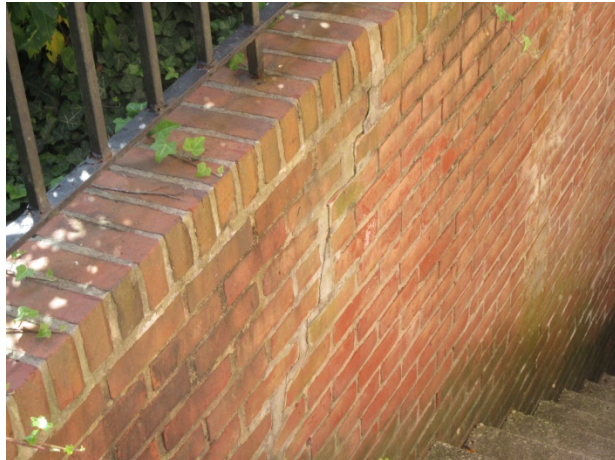
**Condition:** Fair overall with previous repairs and masonry and mortar cracks evident

Retaining wall previous repairs

**Useful Life:** Masonry retaining walls have indeterminate useful lives. However, we recommend the Association plan for inspections and capital repairs every 10- to 15- years to forestall deterioration.

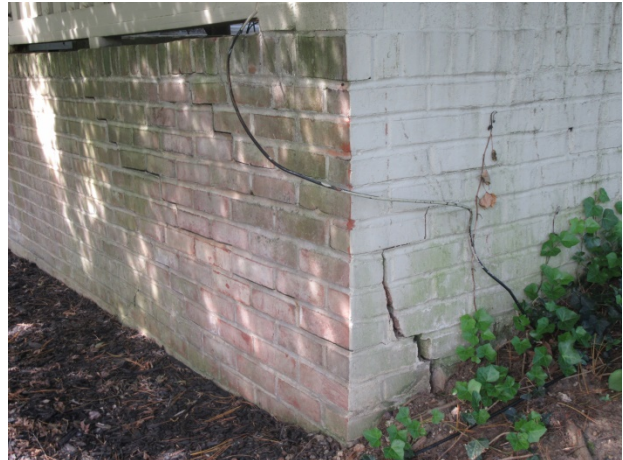
Retaining wall masonry crack

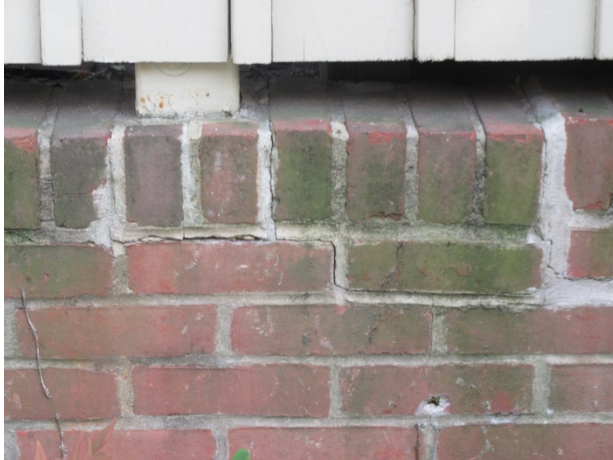
**Retaining wall mortar crack**

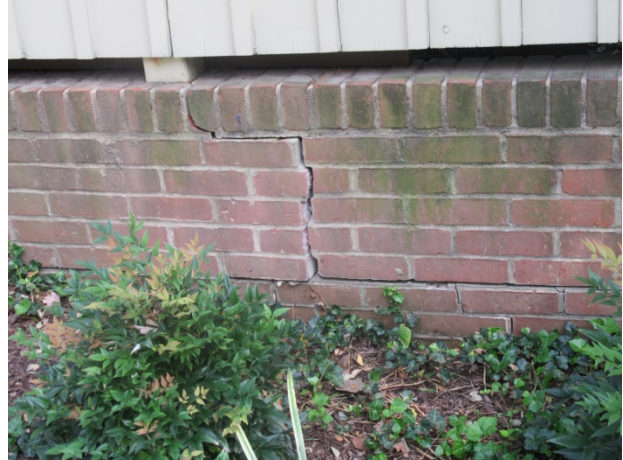
**Retaining wall masonry and mortar cracks**

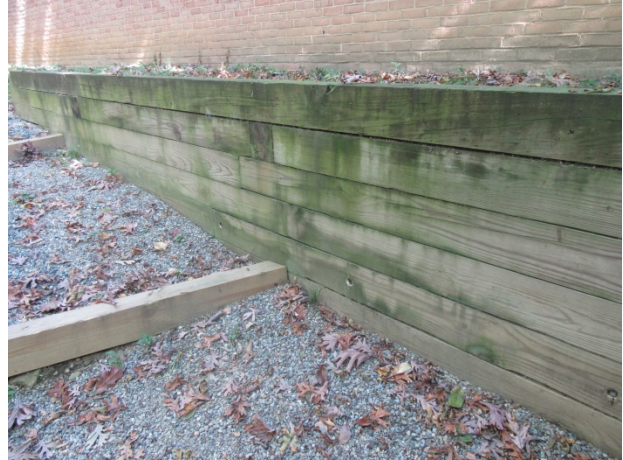
**Condition:** Good to fair overall with organic growth evident

**Timber retaining wall organic growth**
