CROSS KEYS CONDOMINIUM NO. 1 DRAINAGE AND STORMWATER ASSESSMENT AND RECOMMENDATIONS

January 2019

Kelly Lindow, PE
CityScape Engineering, LLC

Jean Mellott, PLA
Grow Landscape Design

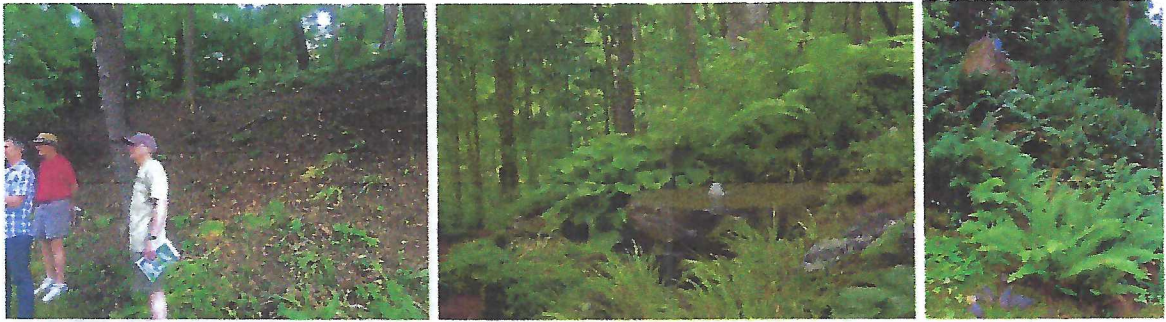
Figure 3. (a) Existing shaded slope lacking groundcover. (b) and (c) Examples of healthy groundcover and understory.

- P1. Establish dense groundcover and understory plantings on shaded hillsides.** There are approximately 30,000 sf of shaded hillside that lack robust understory and groundcover. Planting these areas with dense groundcover plants and shrubs will help stabilize the slope and reduce soil erosion, allow for uptake and evapotranspiration of water, and slow down runoff flowing from the slope. Deer resistant plantings must be selected to ensure plant viability. Due to the steep slopes, it is recommended that coir logs or natural fiber nets be installed to keep soil secure during plant establishment. Mulching should be done at planting and for the first 2 years to reduce weed growth. A list of recommended plants is included in Section 6 of this report.

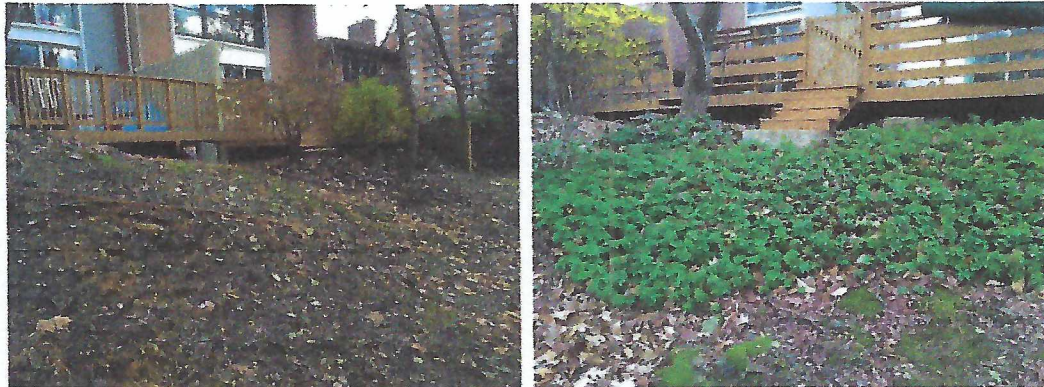
Figure 4. Existing properties along west Bouton Green Ct. with (a) lack of groundcover and (b) established native groundcover.

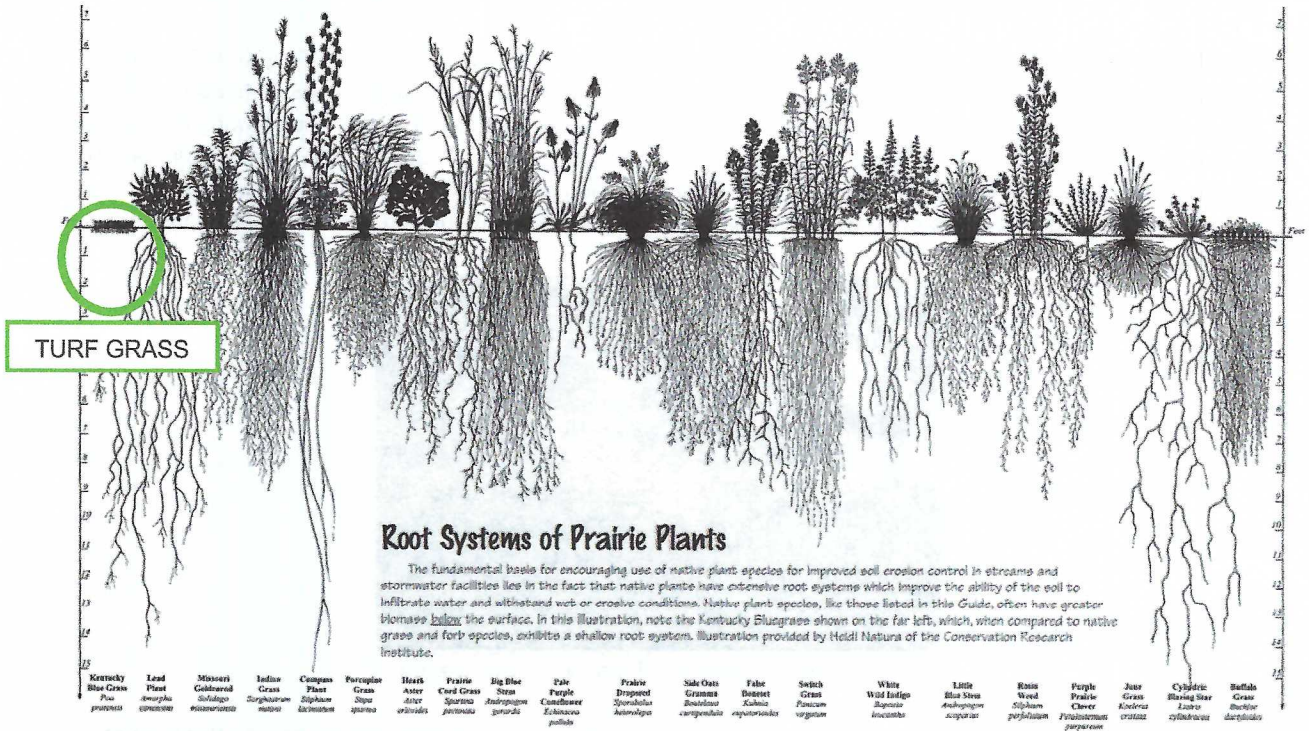
Figure 5. Root systems of meadow plants compared to turf grass. Illustration by Heidi Natura of the Conservation Research Institute.

- P2. Meadow establishment on sunny hillsides.** Roughly 1 acre of steep hillside that is currently mowed turf can be converted to native meadow. Meadow grasses and flowers grow long and deep roots that hold soils in place and soak up greater volumes of water than turf. Comparatively, the roots of common turf grasses only grow a couple inches deep as shown in the illustration below. Meadows can be an attractive site amenity that provide critical habitat for birds and pollinators. A meadow should be carefully planned to select site-appropriate species and will require a few years of close hands-on maintenance to get fully established. However, after these first few years the maintenance requirement will be far less costly and intensive than standard turf. The following is an excerpt from the North America Permaculture magazine,

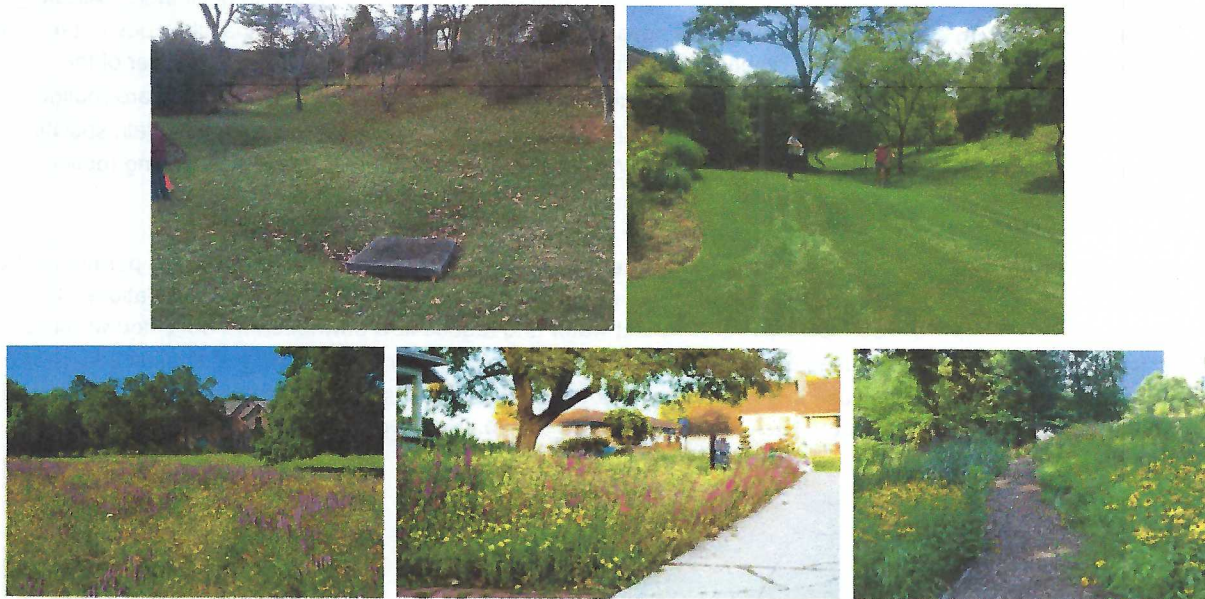
Figure 6. (Top Row) Existing grassed slopes at Cross Keys Condo No. 1 area. (Bottom Row) Examples of urban meadow plantings.

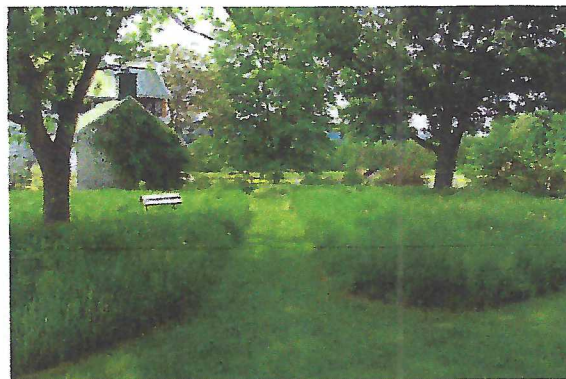
Figure 7. Examples of reduced mowing area.

P4. Aerate turf-area-soils and reduce mowing frequency. Turf groundcover functions poorly to absorb or slow stormwater runoff and provides minimal ecosystem benefits. Mowing of damp soils causes compaction and can result in tire rutting that causes bare spots and exacerbates erosion. Aerating the soils and allowing turf to reach 6, 8 or even 12 inches will promote denser plant cover, encourage growth of deeper roots, and discourage weed germination. When cut, the grass should be left 3-4 inches or longer to maintain a healthy plant base. Decreasing the frequency of mowing will reduce maintenance costs and result in reduced emissions from mowing equipment.

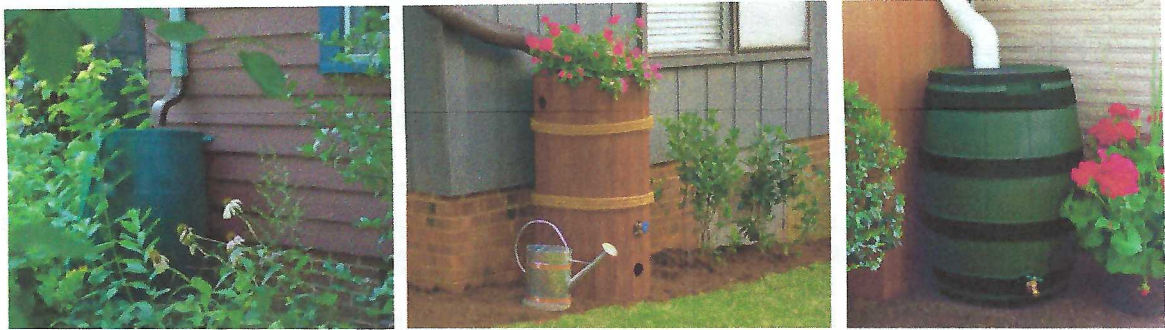
Figure 7. Examples of rain barrels, which typically hold 50 gallons, each.

P6. Consider allowing rain barrels and encourage use by residents who garden. If not currently permitted, the Condo Association should consider allowing the use of rain barrels as part of their rules and regulations. Rain barrels can be installed on roof downspouts to collect water and reduce flow downstream. Collected water can be used to irrigate outdoor gardens or water houseplants. Rain barrels come in a variety of shapes and sizes and can be prominent or disguised in a landscape. They require simple installation and can be done by a handy homeowner or by service providers such as Blue Water Baltimore. Residents should be educated on water reuse options and simple rain barrel maintenance needs.

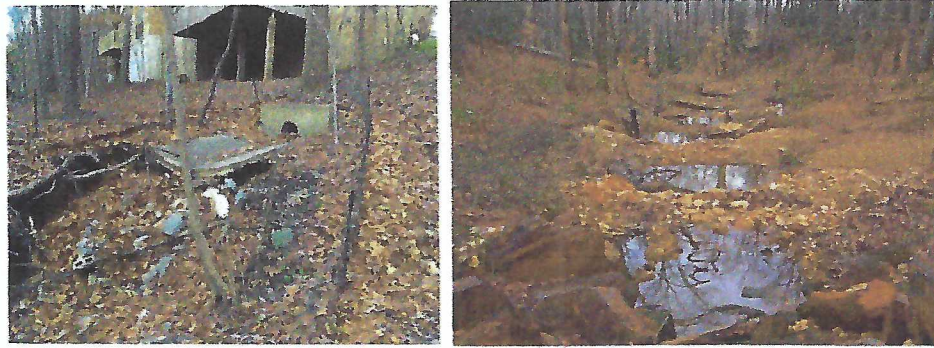
S4. Outfall stabilization. Stabilization of pipe outfalls in the woods along the Jones Falls will help prevent further erosion and silting downstream. Significant erosion was noted at an outfall pipe just north of Condo No. 1 area and is outside the scope of this report. The main outfall from the Condo. No. 1 area was not mapped or located, but scour was observed at a smaller, 4-5" pipe handling the downspouts from the top group Condo No. 1 properties. The site should be fully assessed for outfall locations to evaluate the extent and severity of erosion. For areas of minor outfall erosion, rock or plants can be placed to hold soil in place. At more severely eroded outfalls, step pool stormwater conveyance systems (SPSCs) can be considered to stabilize the channel in an environmentally friendly manner. SPSCs can slow down the conveyance of water down the hillslope and improve water quality through similar mechanisms as bioswales and raingardens.

Figure 11. (a) Existing outfall in need of stabilization, and (b) Example step pool stormwater conveyance system.

5. **Action S4 (Part 1).** Perform follow up assessment of outfall conditions (Winter 2019). Document conditions and perform minor stabilization of outfalls as needed.

12. **Action S4 (Part 2, as needed).** Stabilization of significantly eroded outfalls will require significant design and permitting to implement. (Year 2022)
